# EFFECTS OF TRADITIONAL INSULATION SYSTEMS

# THE SIMPLE SAVER SYSTEM VS. TRADITIONAL METHODS OF INSTALLATION

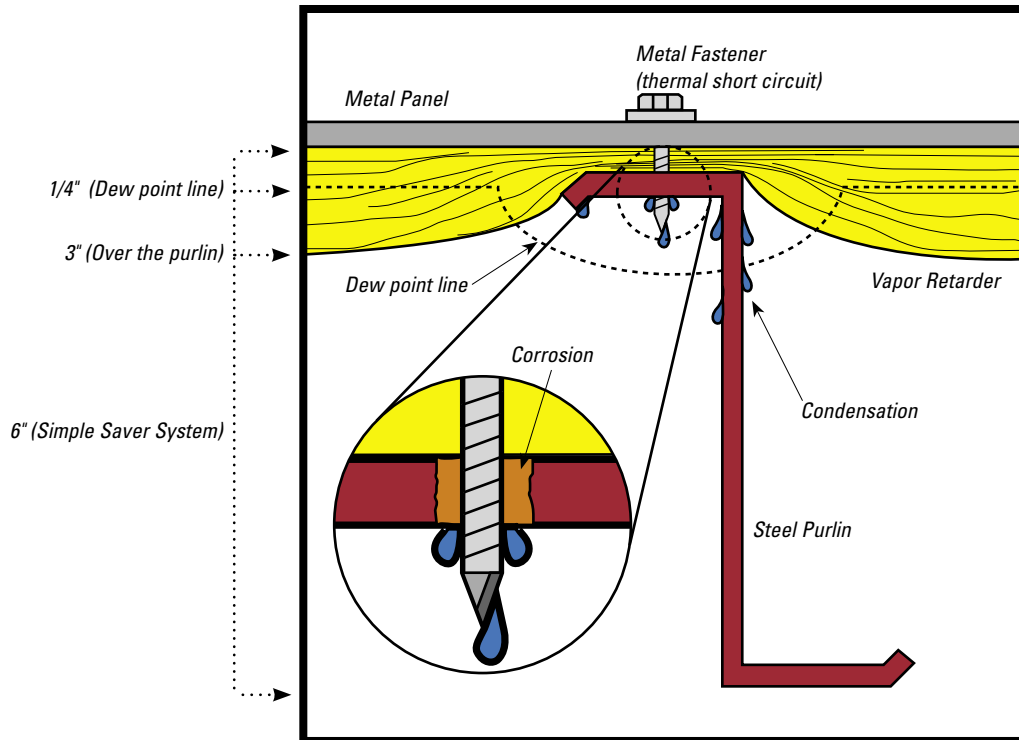
## MAJOR DEFECTS

1. IMPROPER PLACEMENT OF VAPOR RETARDER (OVER THE PURLIN)
2. SEVERE LOSS OF INSULATION VALUE FROM COMPRESSION

## RELATED PROBLEMS WITH TRADITIONAL INSULATION SYSTEMS

| <b>Condensation</b> | Causes dripping, damage to ceilings and building contents, deterioration of facings, and wet insulation. This condensation is often perceived to be caused by roof leaks. |
| <b>Corrosion</b> | Structural deterioration, roof panel deterioration, shortened roof life, high repair costs. Also causes loosening of roof fasteners and standing seam clip fasteners. |
| <b>Exposed Purlins</b> | Unfinished appearance, collects dust and dirt, absorbs light, reflects sound, needs painting and cleaning. Radiates heat from the exterior and transfers cold air into building's interior. |
| <b>Poor Quality In-place Vapor Retarder</b> | Ineffective joint sealing methods destroy perm ratings. Improper placement outside of dew point line results in condensation and corrosion. |
| <b>Obsolete Thermal Performance</b> | Actual insulation values are 50% to 75% less than economically desirable. |

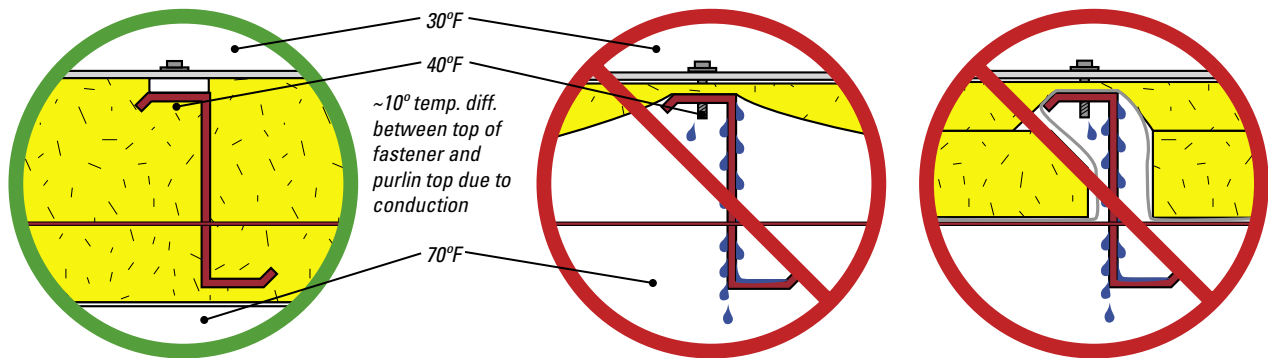
## SIMPLE SAVER SYSTEM

- Full Thickness Insulation
- Proper Vapor Barrier Placement
- Purlins Fully Encapsulated
- Attractive Appearance
- Extrusion Welded Seams

## OVER-THE-PURLIN METHOD

- Severely Compressed Insulation
- Defective Vapor Barrier Placement
- Exposed Conductive Structure
- Unfinished Appearance
- Poorly Sealed Seams

## LONG TAB OVER PURLIN

- Compressed Insulation
- Defective Vapor Barrier Placement
- Voids in Insulation
- Exposed Conductive Structure
- Unfinished Appearance
- Poorly Sealed Seams
